<i>i</i> /, ,	CLASSIFICATION SECRE	25X1
COUNTRY	Soviet Zone of Cormany 25X1 REPORT NO.	
	Railroad Bridge over the Libe River in Ceissen	
TOPIC	William plings over one most track with cipacit	or publishments markishments, mekkenda // a antika-mark fem och (a as alah antikasa)
		THE PROPERTY AND A THE CONTINUES AS A THE SESSION WHICH SERVICE AND A THE SERVICE AND A THE SERVICE AND A SERVICE AS A THE SE
EVALUATION	PLACE OBTAINED_	25X1
DATE OF CONT	<u>25X1</u>	والمراوات
DATE OBTAINE	D 25X1 DATE PREPARED 7 Nugus	t 1950
REFERENCES_		
	2 ENCLOSURES (NO. & TYPE) 2-)	mayora a-
PAGES	URN TO CIA	
REMARKS		- 25 State - Court is indicated the company and a state of the court in the court is the court in the court i
dereka nijeka prikaje Majirani kili karamen kilada i Maje e Alijek i Alijek	25X1 LBRARY	
		EVALUATE
	77	Pro am to be a
	The bridge, 200 meters upstream Reissen highway bridge is on the Dresden (K 52.	/1° 29) -

Coswig (N 52/F 27) - Heissen - Doobeln (N 52/K 79) Grossbothen (N 52/K 59) - Leipzig (N 52/E 21) trunk line,
which is now single-track. See Annex 2 for photograph of
the bridge. The bridge is of considerable importance for
rail operation in the Saxon industrial area although t

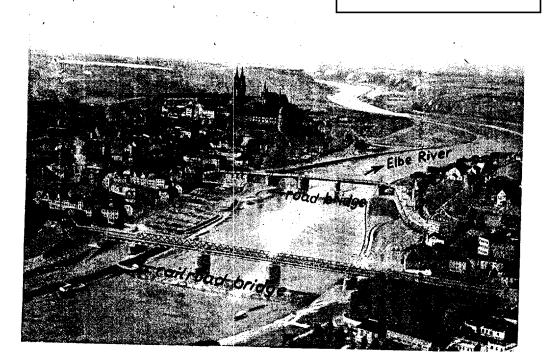
Bridges in Meissen

to be operated again as a double-track line, the remaining
work can be performed very quickly. The sidewalk of the
bridge, 3 meters wide, is usable. The water depth at the
bridge is 1½ meters at mean wa er, 10 meters at high water.
The river is normally 110 meters wide under bridge and the
river bottom and banks are rocky. No data are available on
demolition holes in piers or abutments. AA emplacements or
